Inspection Report

Albert Junkin 123 Orchard Drive Merigold, MS 38759

Junkin Inspection Services

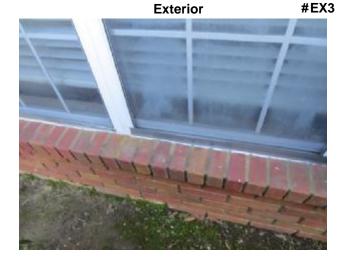
#EX2

Wood trim showed signs of paint peeling, loose caulking, delamination, moisture penetration in several areas,

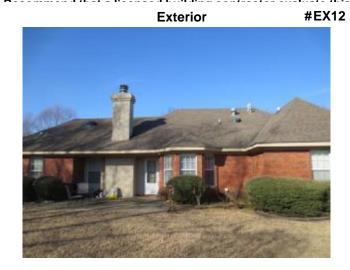
Wood trim showed signs of paint peeling, loose caulking, delamination, moisture penetration in several areas,

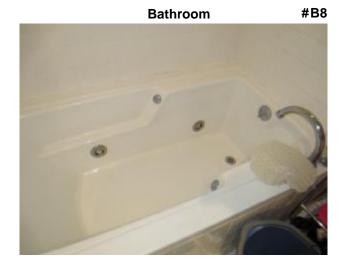
Bathroom #B7

Some areas in home at walls and ceiling need repair and paint. (Closet in master bath. Also see ceiling photo at master

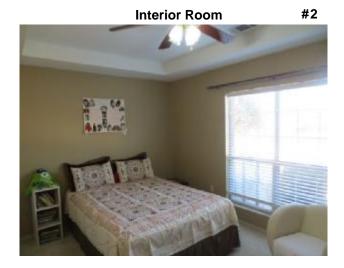
Interior Room #2

Some areas in home at walls and ceiling need repair and paint.

(Closet in master bath. Also see ceiling photo at master

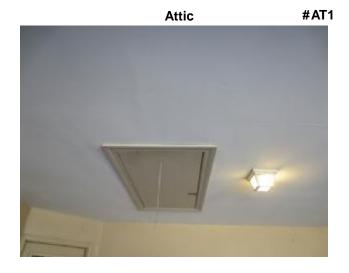
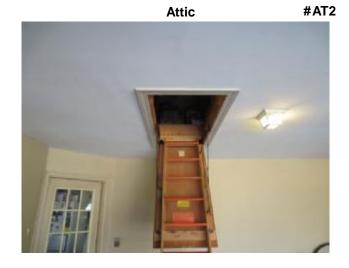
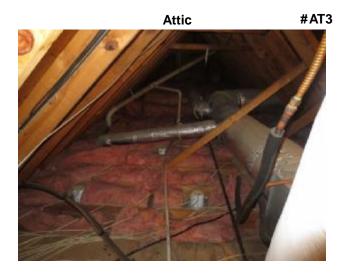
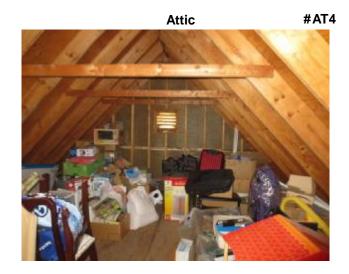
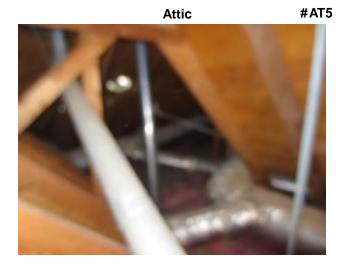
There were signs of possible pests in attic. (Mice).
